# **SPILL PREVENTION AND STORMWATER CONTROL PLAN**

**MOAB SALT, INC.**

POTENTIAL FOR BRINE SEEPAGE ALONG ROCK FRACTURES,  
BRINE LAKE STORAGE AREA,  
CANE CREEK MINE, GRAND COUNTY, UTAH

Prepared by  
EARTHFAX ENGINEERING, INC.  
SALT LAKE CITY, UTAH

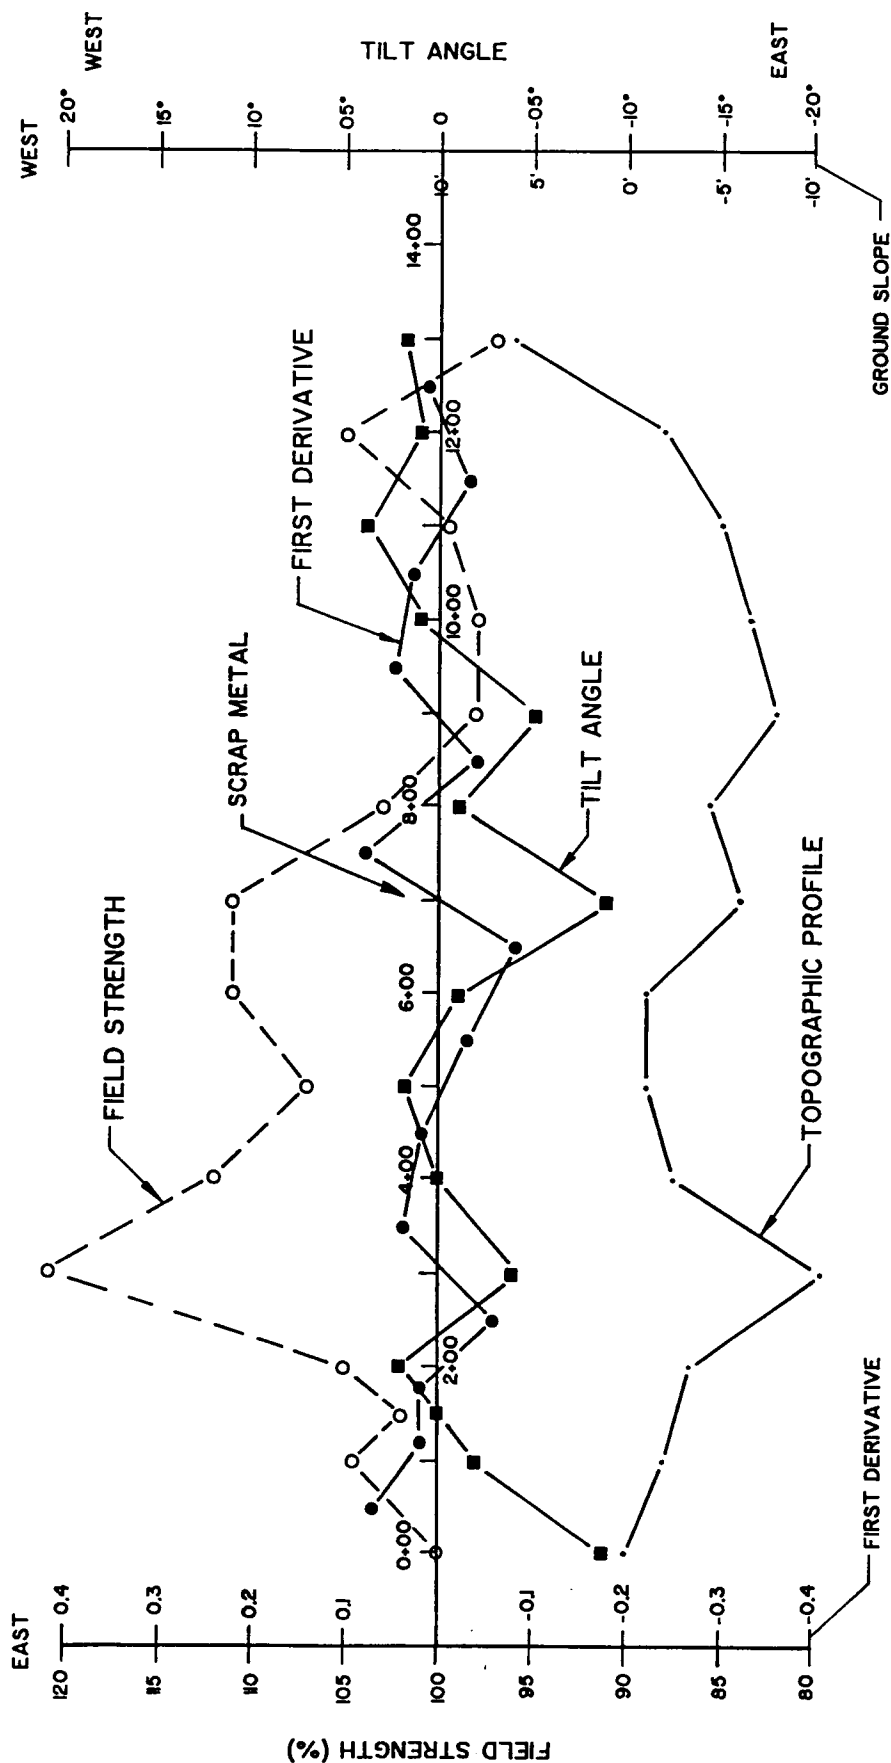
Figure 12. VLF-EM Profile of Line 1.

Three "cross overs" or possible anomalies are shown along line 1 between stations 2+00 - 3+00, 6+00 - 7+00, and 8+00 - 9+00 (Figure 12). However, each possible anomaly shown by the tilt angle of the magnetic field closely mimics the topographic profile (vertical exaggeration 10x) shown in Figure 12, and thus are not considered indicative of conductors. The eastward tilt of the magnetic field at stations 0+00 and 1+00 probably is due to steel piping which lies east of those stations (the field strength was adjusted to 100 percent at station 0+00 and served as the base station; thus, anomalous field strengths were "zeroed-out" at station 0+00).

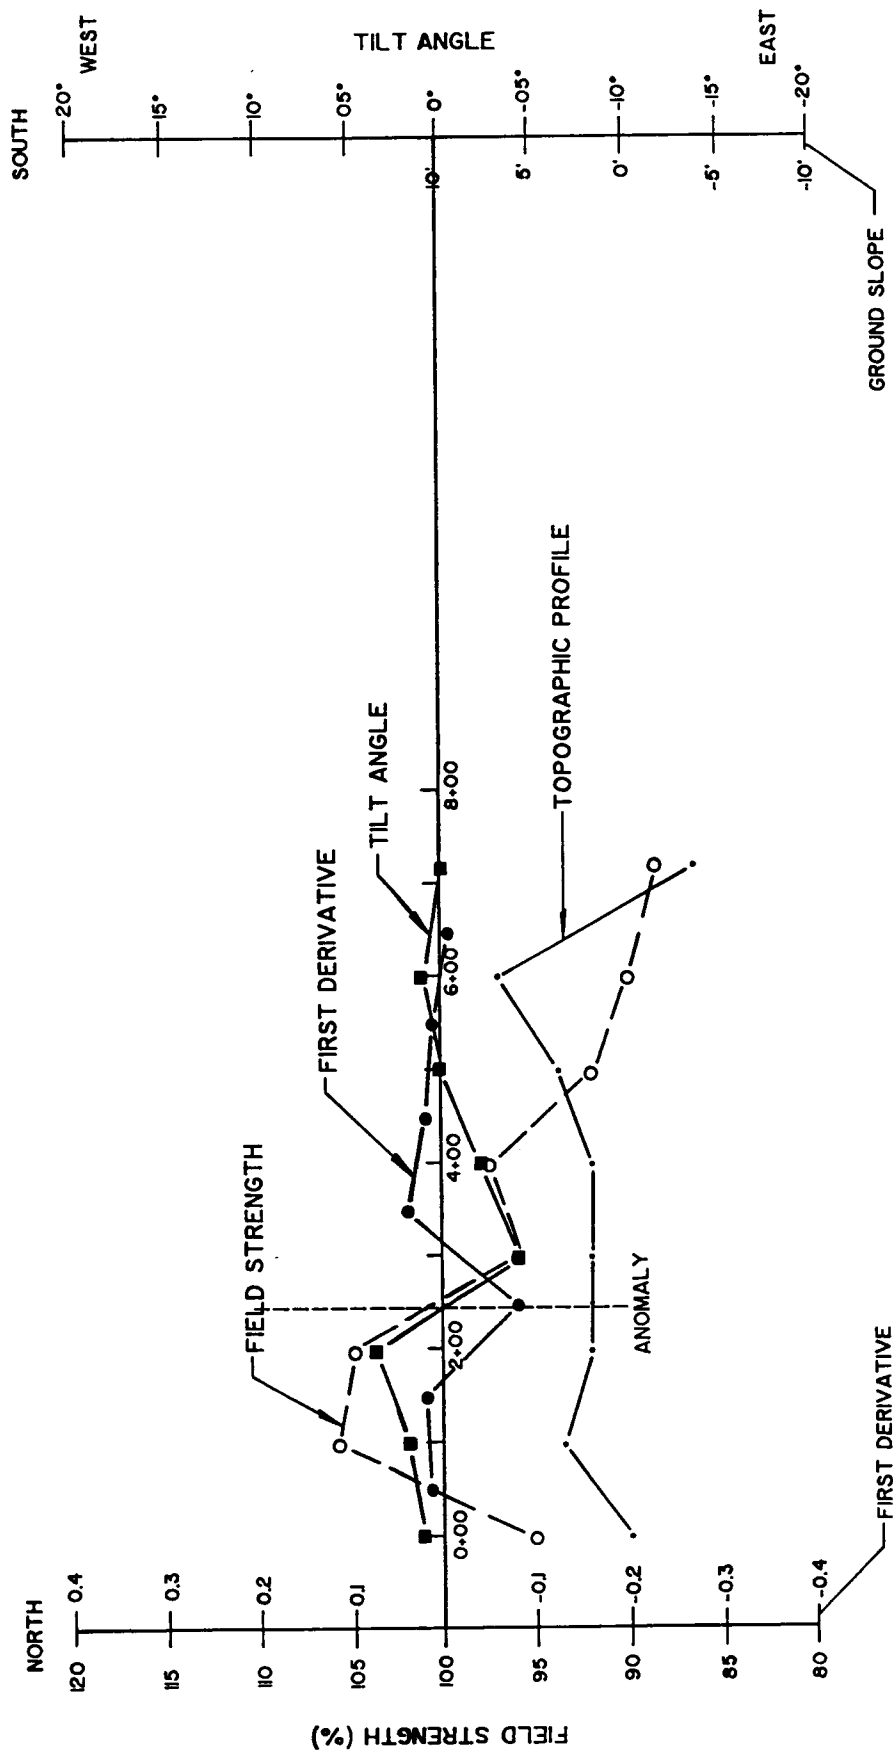
Figure 13. VLF-EM Profile of Line 2.

VLF line 2 runs southward from station 10+00 on line 1 (Figures 4 and 12). One probable anomaly is present on line 2 between stations 2+00 and 3+00 as shown in Figure 13. Note that the topographic profile is nearly level and the first derivative profile of the tilt angle is symmetrical and shows a change greater than 0.1 degree per foot. This anomaly may suggest brine seepage along fractures associated with fault D (Figure 4). Because rugged topography lies west of the line and conductive overburden (Tertiary and Quaternary terrace and stream deposits) lies east of the line, additional north-south lines were not surveyed.

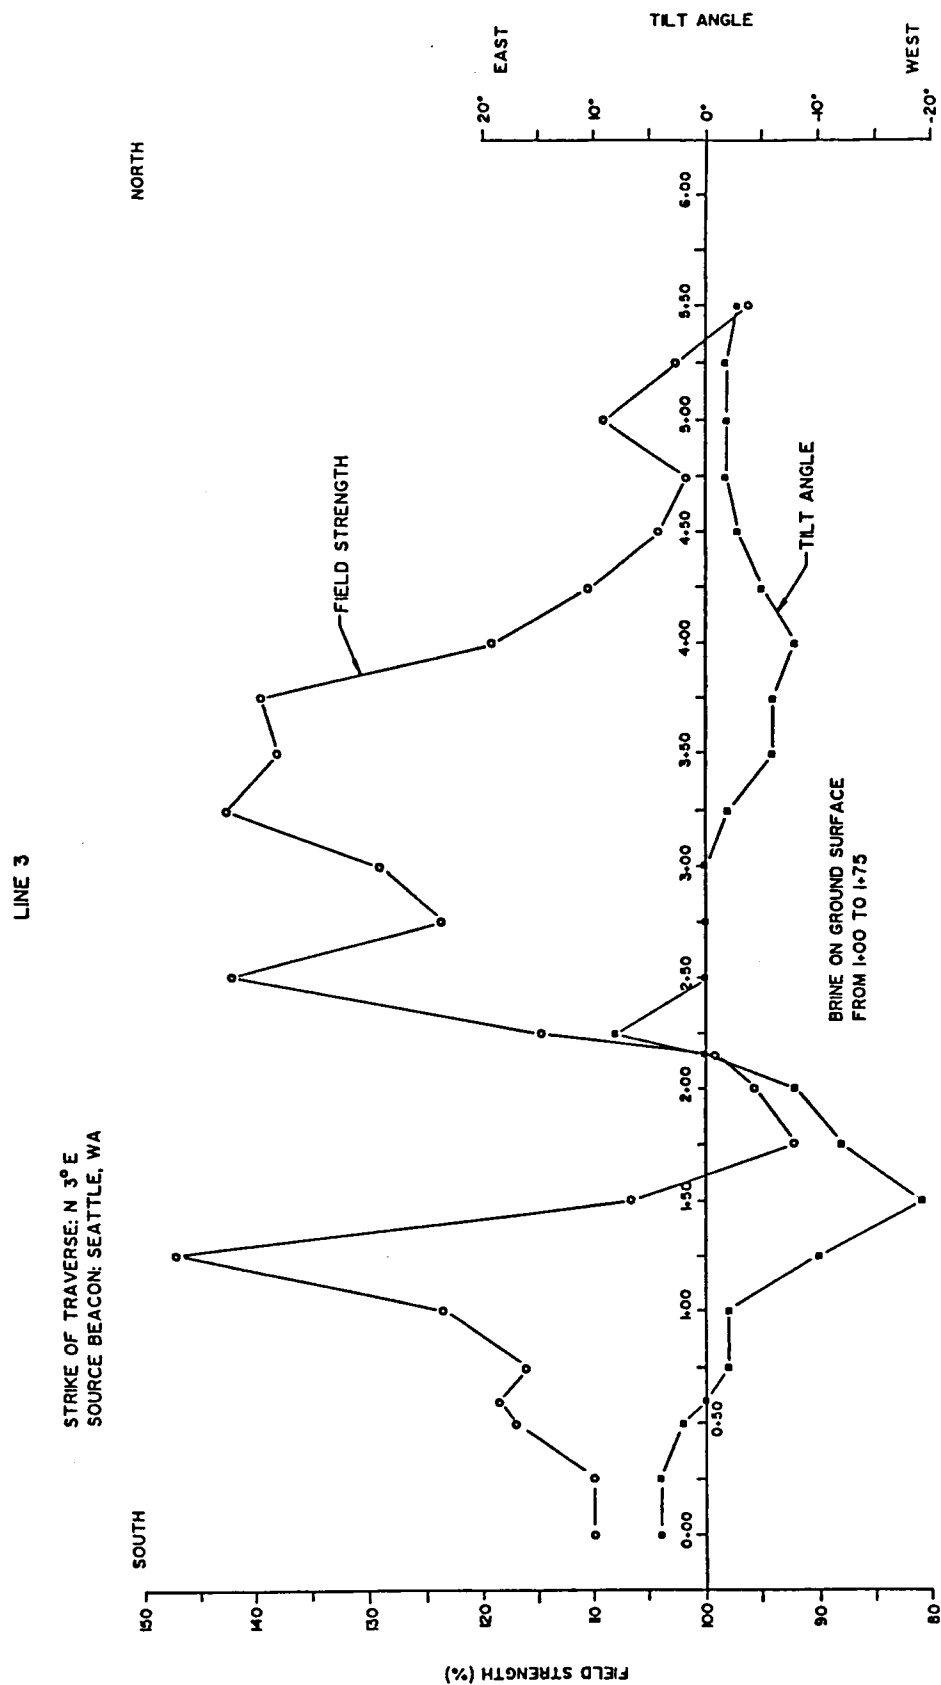
Figure 14. VLF-EM Profile of Line 3.

The anomaly shown between stations 0+50 and 0+75 on line 3 is coincident with a joint which intercepts the dam spillway. At the time of the survey, this joint was releasing small quantities brine to the ground surface. Fractures associated with fault B (Figure 4) are nearly coincident with station 1+00. Magnetic field strengths are accentuated at stations 1+00 through 1+50 and 2+25 through 4+00, although no sharp "cross overs" were recorded. Brine was present along the ground surface between stations 1+00 and 1+50 (see Figure 10), and

probably was just below the ground surface between stations 2+25 and 4+00, thus the magnetic profile shown in these areas may be reflective of one or two diffuse anomalies unlike what would be expected if brine was confined to rock fractures only.

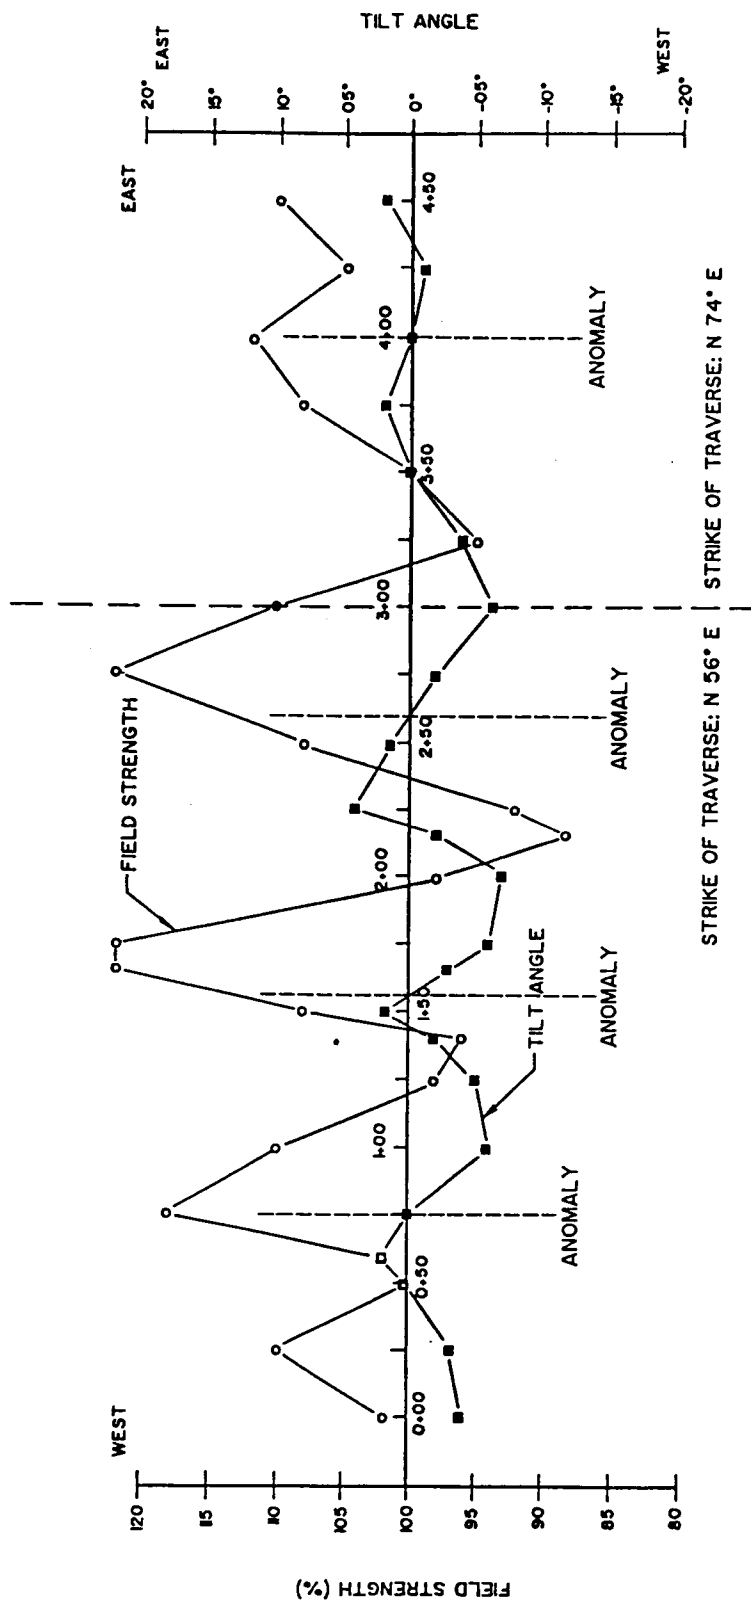
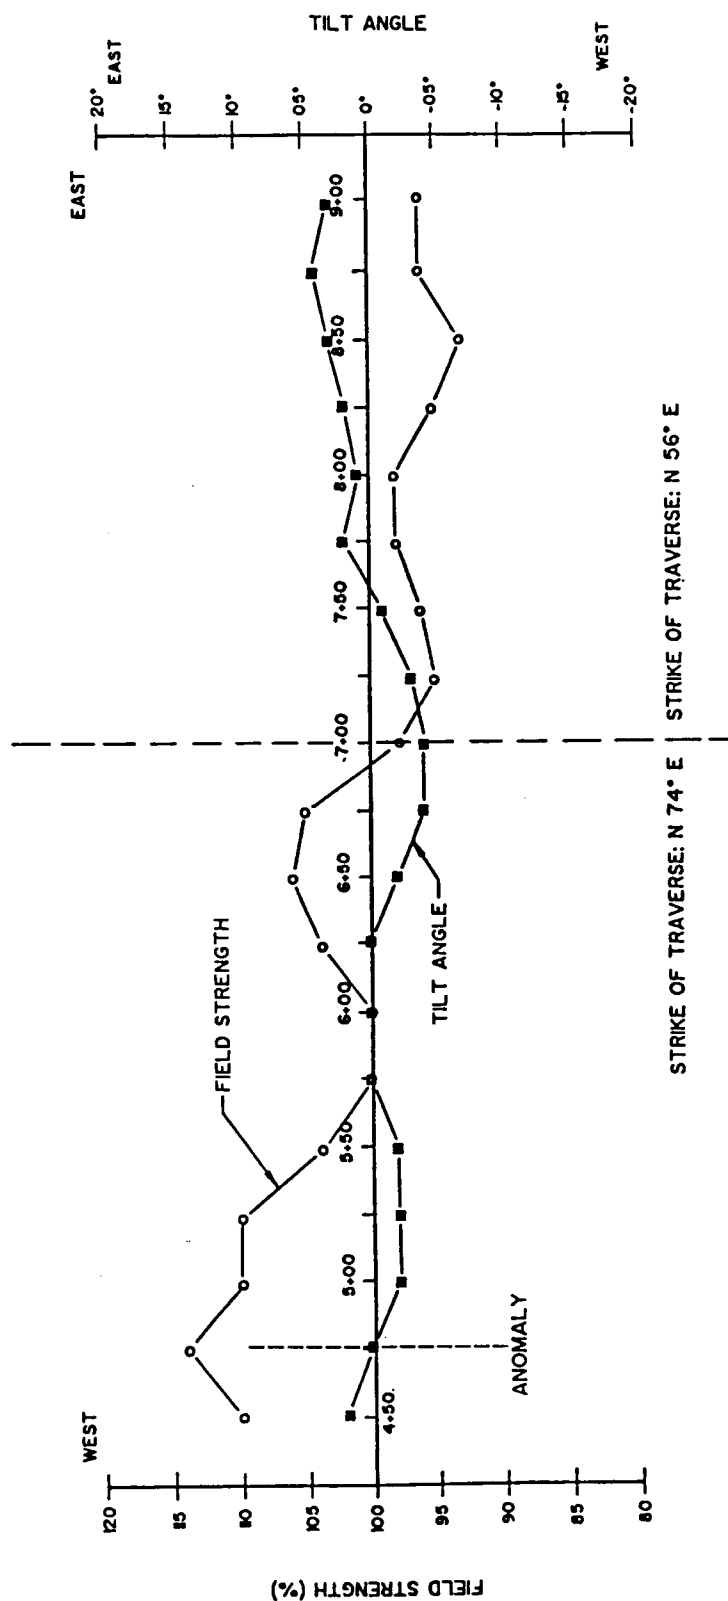
Figure 15. VLF-EM Profile of Line 4.

Five anomalies are present along line 4 at stations 0+75, 4+00, 4+75, and between stations 1+50 - 1+75, and 2+50 - 2+75. Each of these anomalies is associated with fractured sandstone in the arroyo. Brine was not present on the ground surface at the time of the survey; nor was there evidence of past brine evaporation at the ground surface along the traverse.

Rock fractures associated with the first three anomalies along line 4 (stations 0+75, 1+50 - 1+75, and 2+50 - 2+75) intercept the north abutment of the brine lake dam. The westernmost of the three anomalies is nearly coincident with fault A which underlies the first catchment pond at the toe of the dam as shown in Figure 4. The last two anomalies along line 4 (stations 4+00 and 4+75) are not as accentuated in terms of field strength or changes in tilt angle as are the three anomalies to the west. Rock fractures associated with the latter anomalies intercept the area of the second catchment pond below the dam. It is probable that the rock fractures associated with the three western anomalies are receiving brine recharge from the area of the upper catchment pond, whereas fractures associated with the two easternmost anomalies may be receiving recharge from the area of the second catchment pond.

Because anomalies are absent along the last 400 feet of line 4, it is unlikely that rock fractures in this area are receiving brine recharge from the brine lake or catchment ponds below the toe of the dam. This suggests that brine seepage associated with the dam and spillway is controlled by the bedrock
